**SHIQAQ HAI MUSALLA
PRIMARY HEALTHCARE CENTER
KIRKUK, IRAQ**

SUSTAINMENT ASSESSMENT

**SIGIR PA-08-157
APRIL 13, 2009**

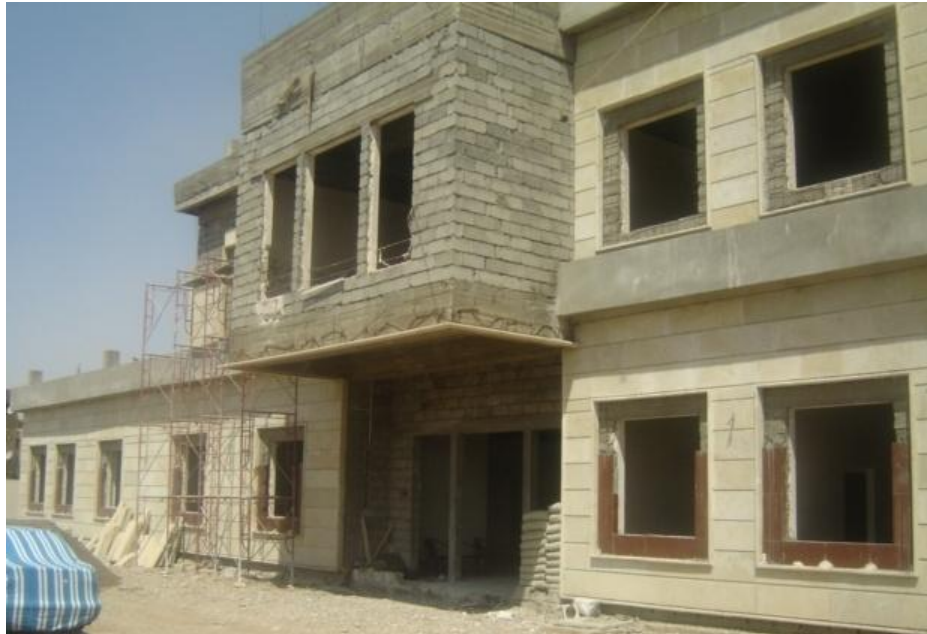
Site Photo 1. Condition of partially constructed PHC when new contract was awarded (Courtesy of GRN)

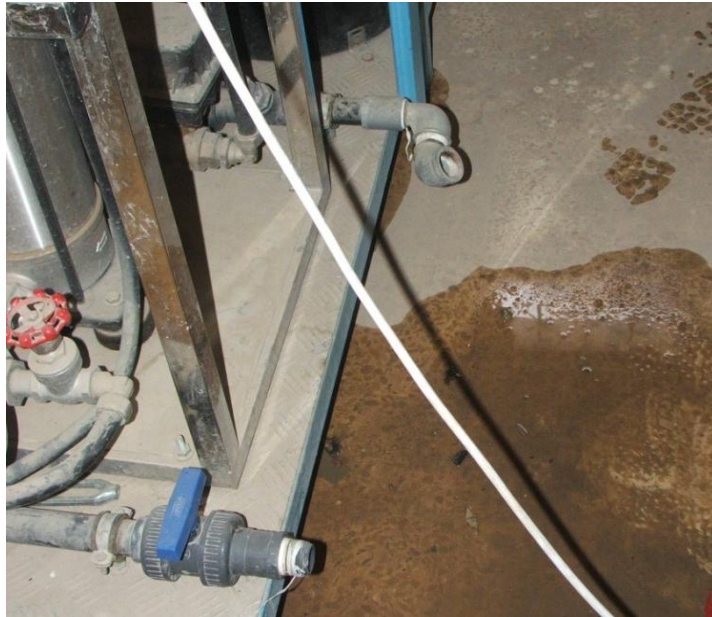
Site Photo 5. Disconnected RO unit

The RO unit appeared to be installed, but had been disconnected from the facility's water system (Site Photo 5). The PHC administrator did not respond to several requests by SIGIR as to who disconnected the RO and why.

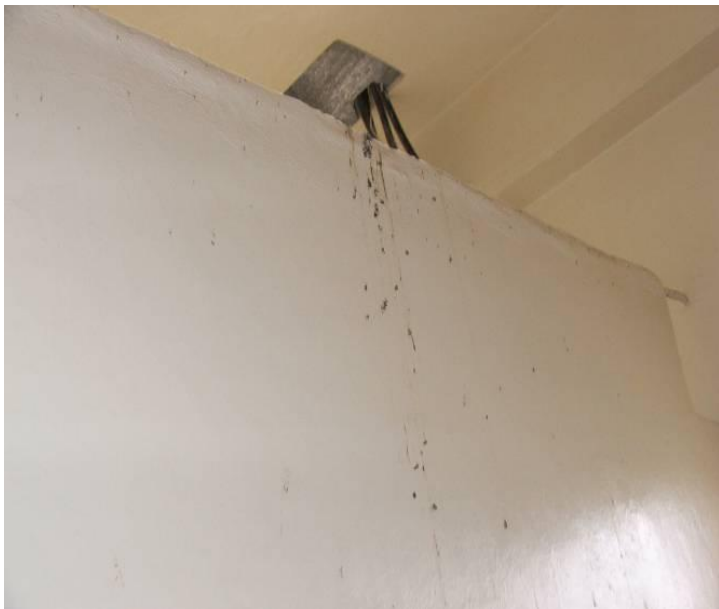
SIGIR observed evidence that birds were nesting in the general vicinity of the RO unit and potable water equalization tanks, with bird feces visible on the partition wall (Site Photo 6). In addition, one of the tank lids was open, permitting contamination of the potable water supply (Site Photo 7). Contamination of the water supply with bird feces increases the risk of exposure to patients and staff of avian born diseases such as histoplasmosis, cryptococcosis, or psittacosis.

Site Photo 6. Possible water contamination source

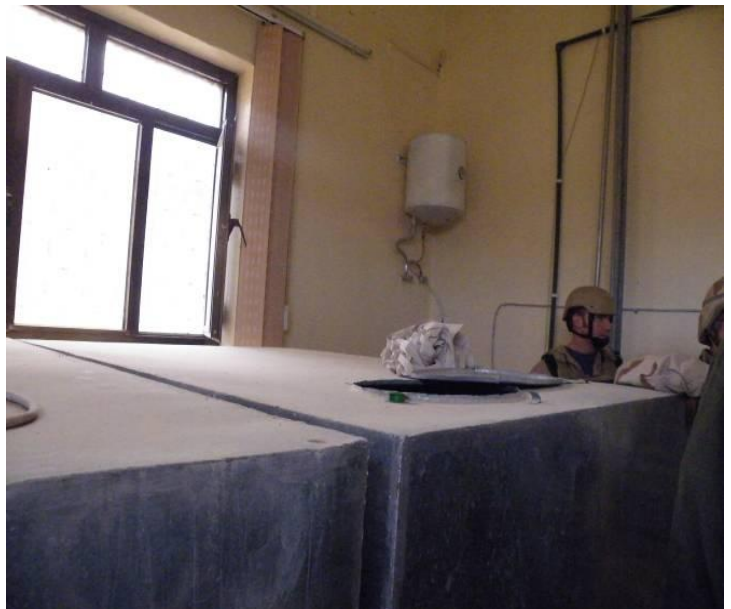
Site Photo 7. Uncovered equilization tank

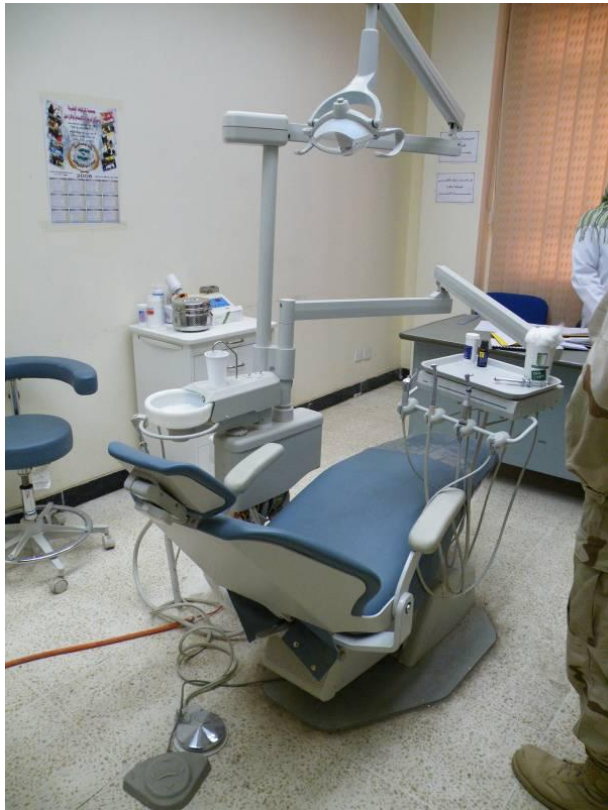
Site Photo 8. Dental chair and tools

During the site visit, SIGIR observed that the dental chairs were installed and appeared to be in use (Site Photo 8). During the inspection, SIGIR observed a dentist treating a patient while using the dental chair.

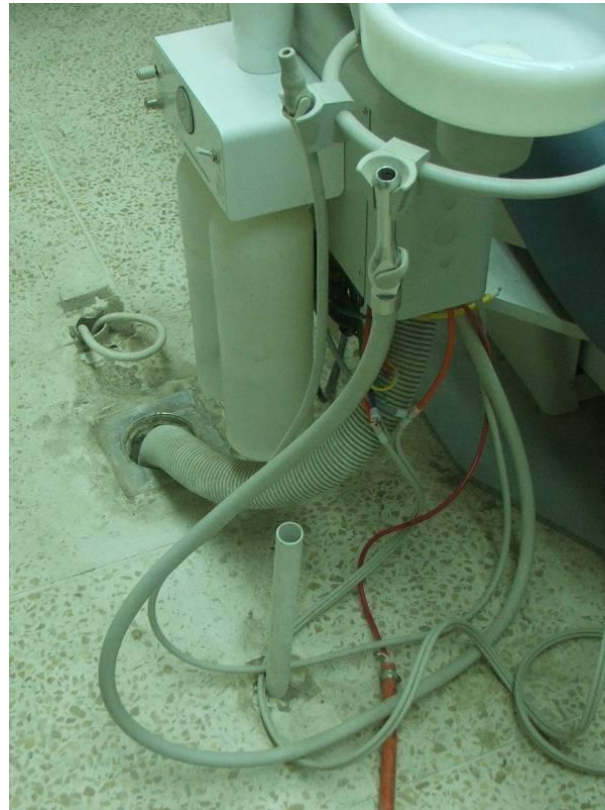
The contractor's installation of the dental chairs, while functional, did not appear to conform to any known plumbing or electric code. The drain for the chairs was placed directly into the floor drain with a significant gap between the floor drainpipe and the chair discharge hose. The electrical connection for the chair was made using a modified extension cord (Site Photo 9).

Site Photo 9. Dental chair connections

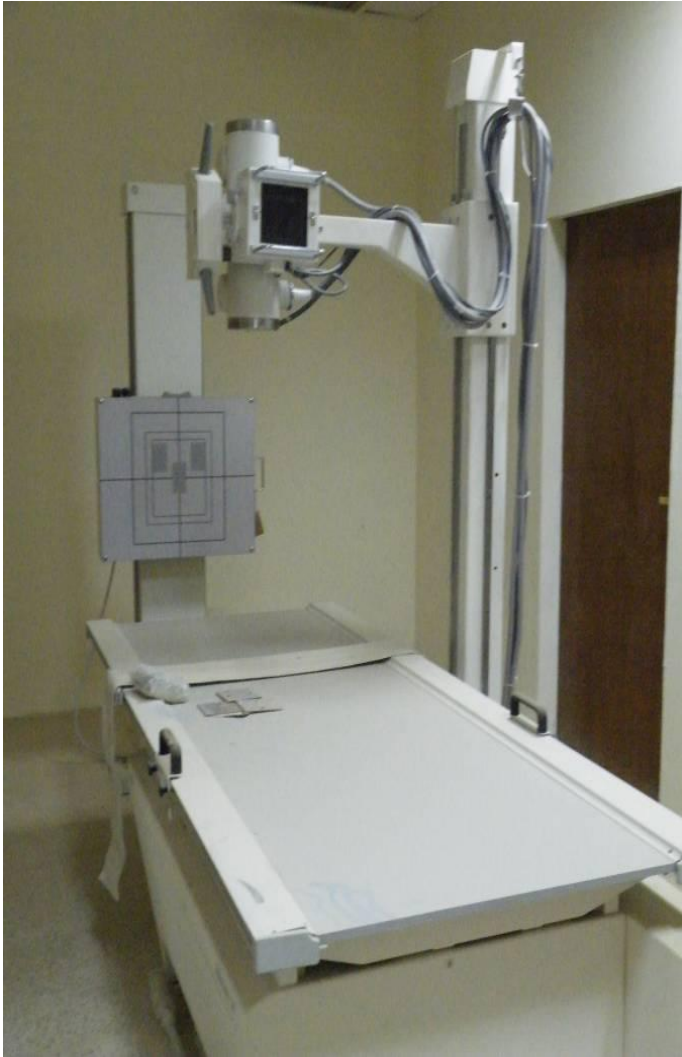
Site Photo 10. X-ray equipment

The original design of the facility included medical imaging capabilities, specifically an x-ray room and equipment. SIGIR observed that the x-ray equipment was installed (Site Photo 10); however, according to the administrator, the contractor did not verify the equipment was operational. In addition, the administrator stated that the facility's staff did not have the capability to operate the x-ray equipment; consequently, the facility does not offer x-ray service to its patients.

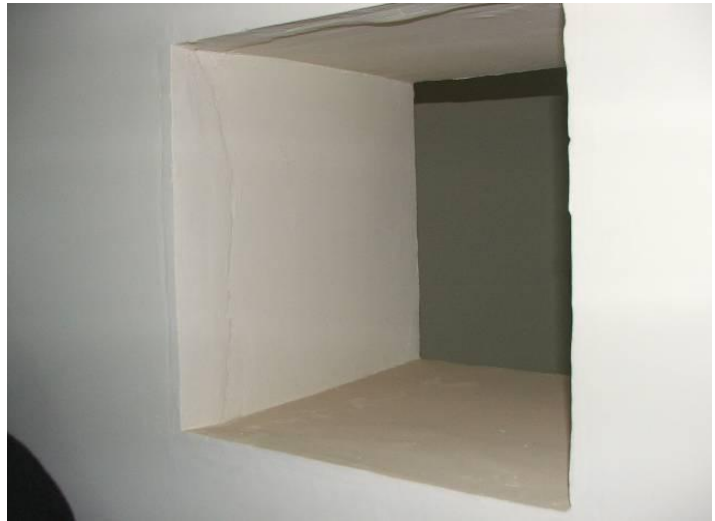
In the 19 July 2007 acceptance letter, one of the two noted deficiencies was “x-ray leaded glass,” which was to be “installed later.” SIGIR noted that the contractor had not installed the required leaded-glass observation window (Site Photo 11). In addition, SIGIR noticed that the x-ray room exterior door and darkroom doors installed by the contractor appeared to be standard wooden doors. The inspection team could not verify the presence of lead lining on the concrete walls.

Site Photo 11. Missing observation window

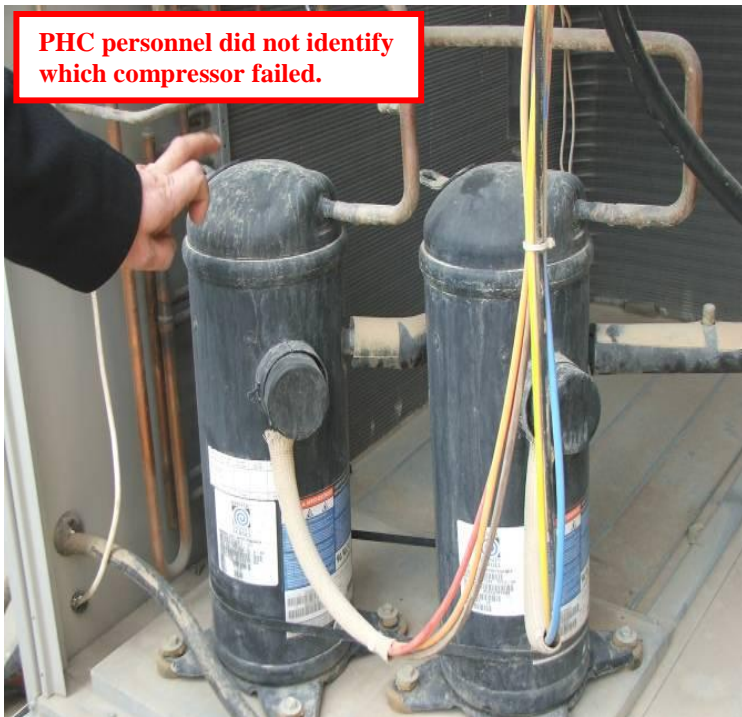
Due to security concerns, only one SIGIR team member was allowed to briefly access the roof to inspect the HVAC units. While on the roof, PHC personnel removed the side panel of one of the primary units for inspection (Site Photo 12). The administrator pointed out that one of the two compressors in the primary HVAC unit had failed, and currently, the facility was operating on reduced capacity.

Site Photo 12. Failed HVAC compressor

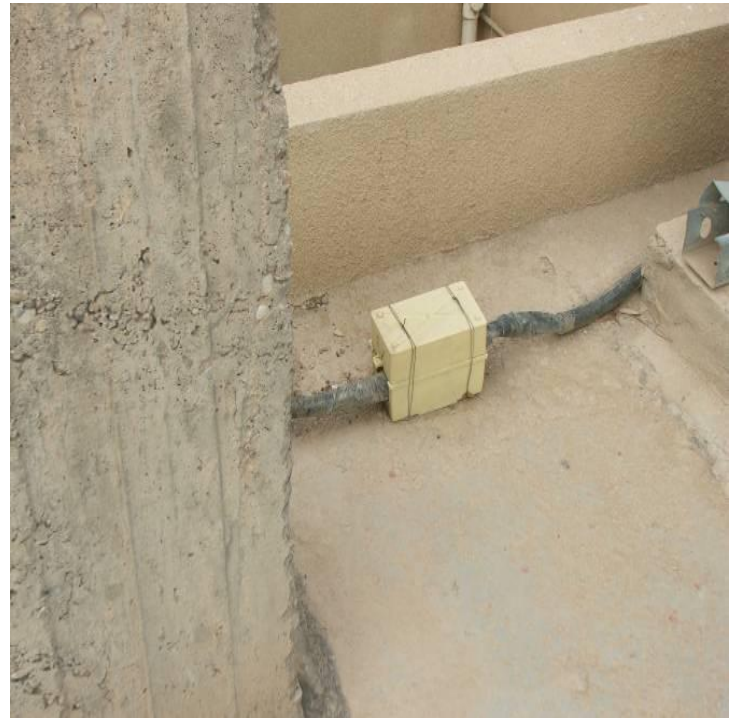
SIGIR noticed several splices of the electric cables for the units. The splices did not appear to conform to the International Electric Code, and in several locations it appeared that plastic index card boxes were modified to act as junction boxes for the electric power supply to the HVAC units (Site Photo 13). Due to the risk of severe shock, SIGIR did not dismantle the makeshift covering, and, as a result, was unable to determine if there was a splice. Since the makeshift junction was located on the roof, the connection was exposed to the harsh weather elements. Due to the significant electric current required to operate the HVAC, shorting of these lines would cause a serious risk of electrical shock and fire.

Site Photo 13. Makeshift electrical junction

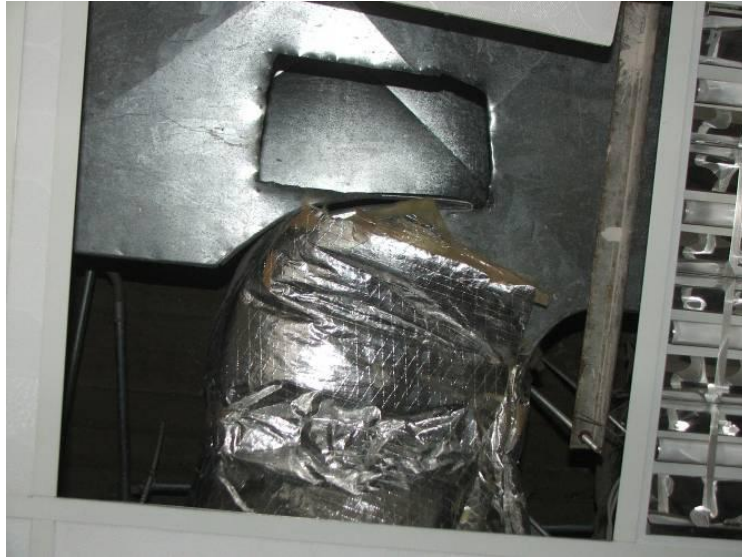
The administrator also stated that the heating units were not working. Based on SIGIR's observations on the roof, it appeared that the HVAC units were equipped with the ability to provide heat; however, the cause of the heating system failure could not be determined. SIGIR noticed that the staff was using small electric heaters to provide heat at individual workstations. The use of the small electric heaters taxes the emergency generator, while being inefficient and a significant fire hazard.

Site Photo 14. Modified HVAC duct

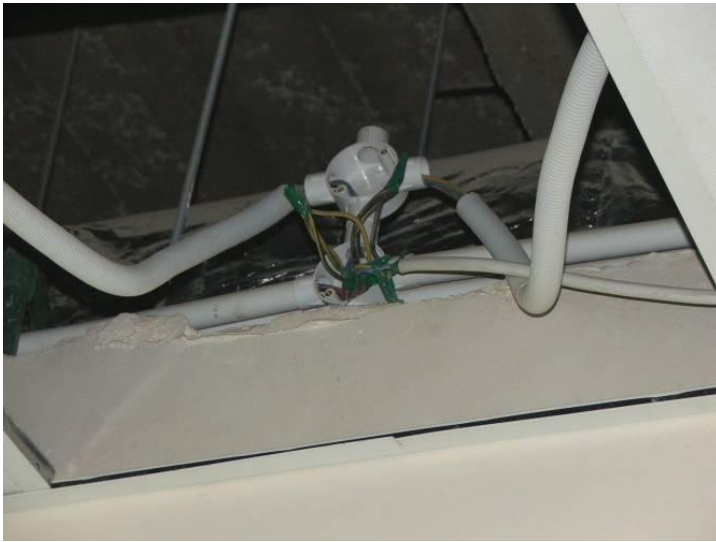
SIGIR observed several questionable electrical connections; none of which conform to the International Electric Code (Site Photo 15). Due to time limitations on site and the fact that the PHC staff had occupied the facility for over a year, SIGIR could not determine if the original contractor performed this work or if it had been "modified" by PHC personnel.

Site Photo 15. Poor electrical connection

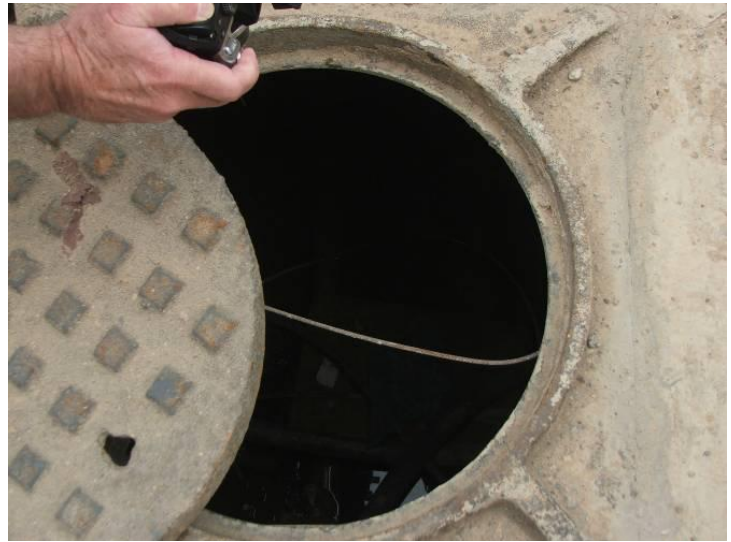
SIGIR noticed that several of the electric manholes had standing water in them (Site Photo 16). Also, there was debris in the manholes, but it was unclear if the debris was left from the original construction, or if it had been deposited recently.

Site Photo 16. Debris and water in electric manhole

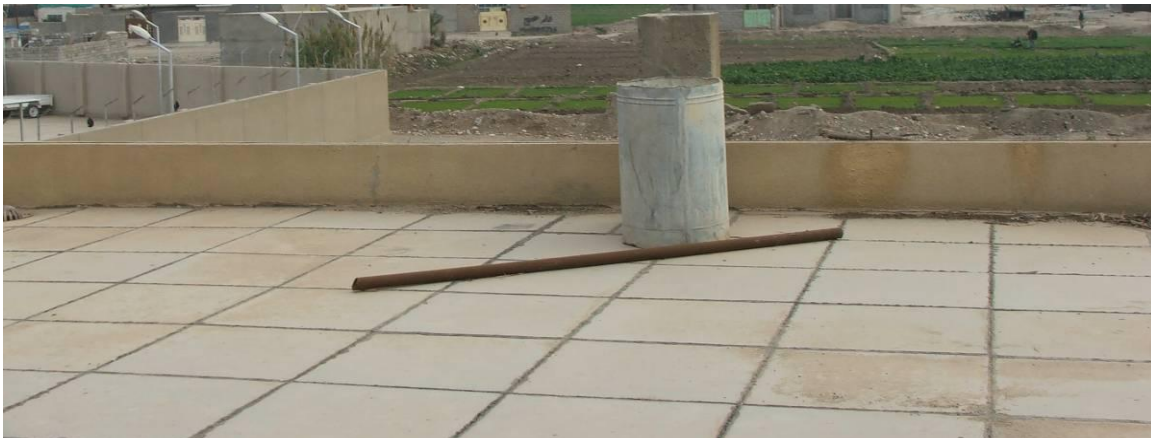
According to the administrator, the mastic between the concrete roof tiles (steigers) was poorly placed and substandard. SIGIR observed that the mastic did not appear inadequate, and the placement of the mastic was typical of other new construction seen at other project sites (Site Photo 17). Poor roof construction would generally lead to interior leaks within the PHC; however, SIGIR did not observe any leaks nor did the administrator mention any interior leaks. The administrator stated that the upper level roof was in worse condition than the lower roof; however, due to security concerns, SIGIR was not allowed access to the upper level roof. Therefore, SIGIR could neither confirm nor deny the administrator's allegation.

Site Photo 17. Quality of roof construction
